# **Technical Report – R20129**

## **CWCT – Standard for systemised building envelopes – 2005**

**Wienerberger Ltd**  
**SVK Fibre Cement Facades**

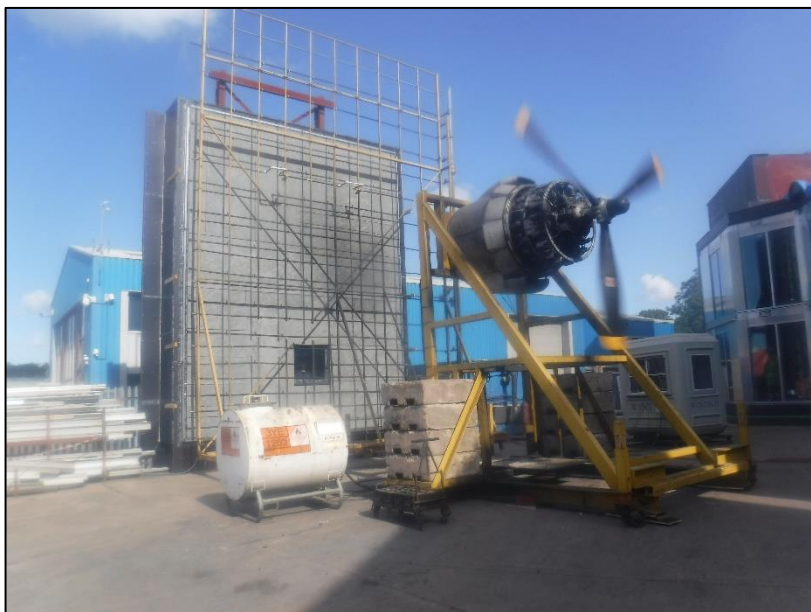
Photograph No. 1

**Sample during testing**

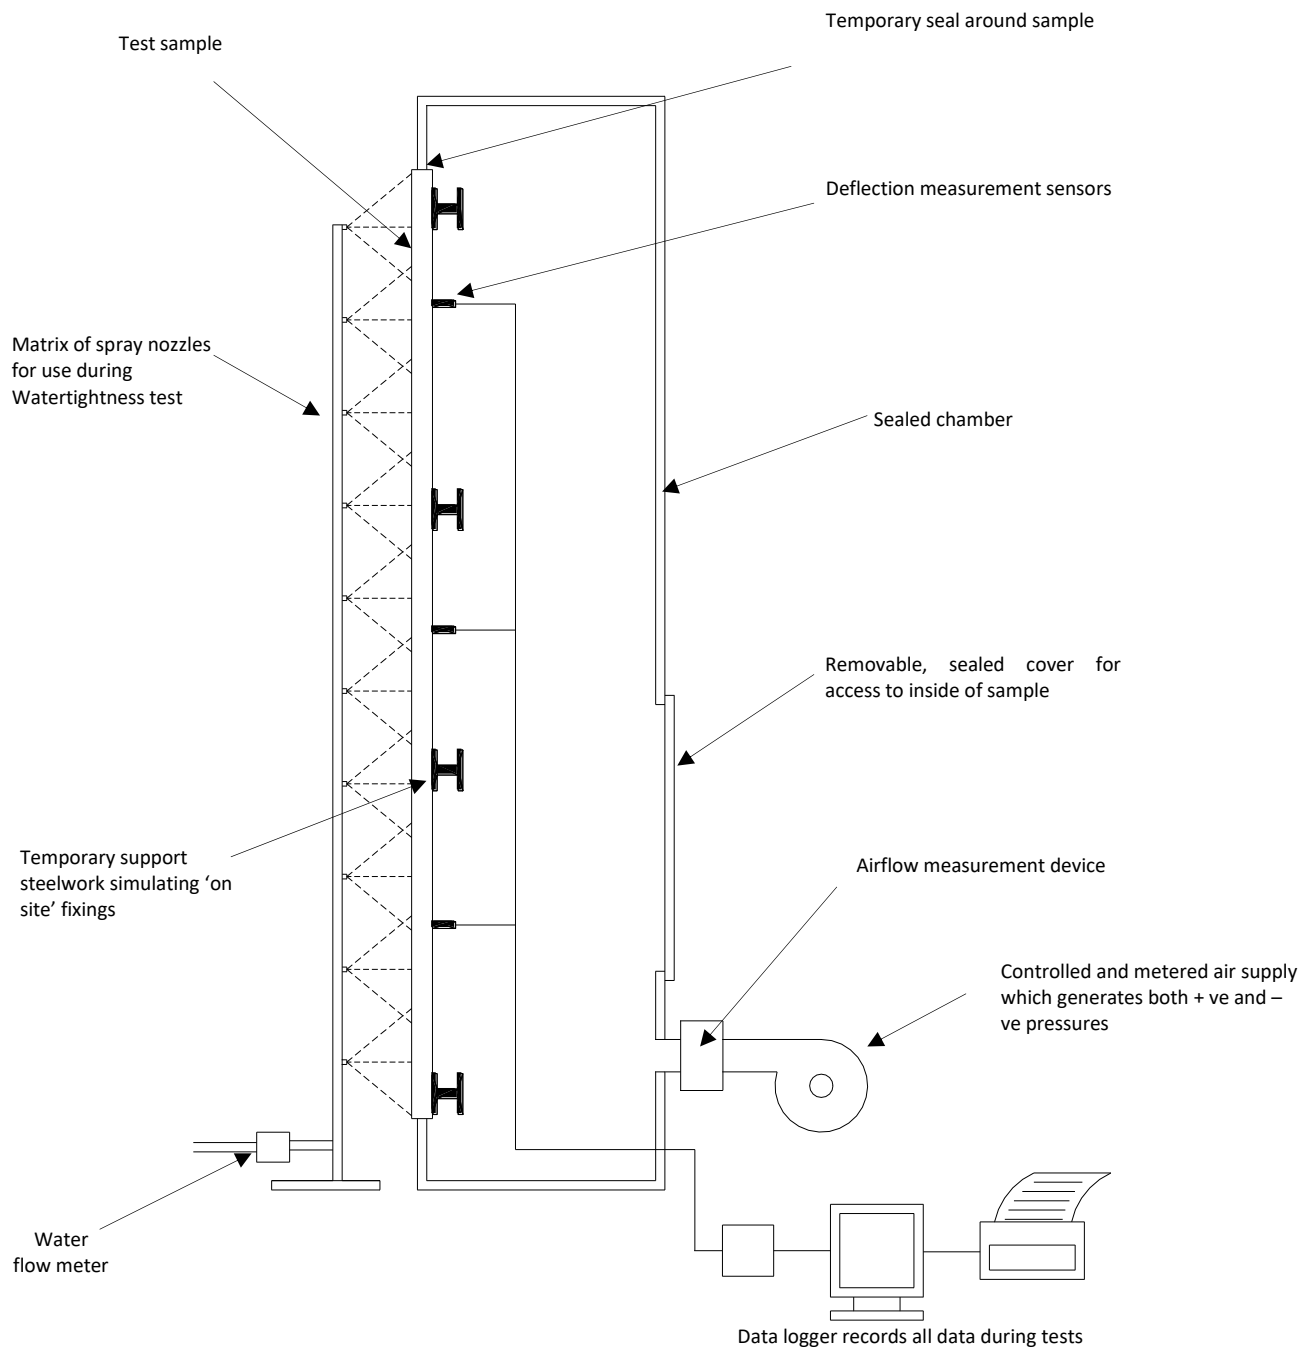
Figure 1 – Test arrangement

General Arrangement of a Typical Test Assembly

A specimen, supplied for testing in accordance with CWCT requirements, was mounted on to a rigid test chamber constructed from steel, timber and plywood sheeting.

The pressure within the chamber was controlled by means of a centrifugal fan and a system of ducting and valves. The static pressure difference between the outside and inside of the chamber was measured by means of a differential pressure transmitter.

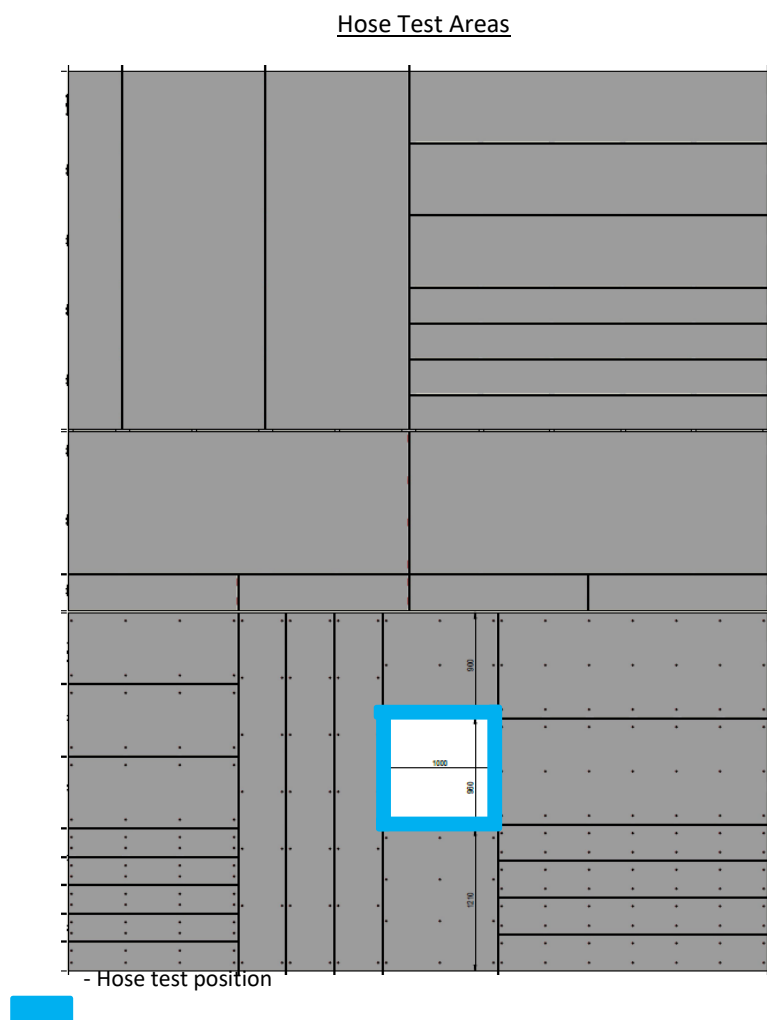
Figure 2

View from Outside  
Not to Scale

The sample was subjected to hose testing, as described in section 5.2.2. During the test, and for 30 minutes following the cessation of spraying, the sample was monitored for water ingress and none was found.

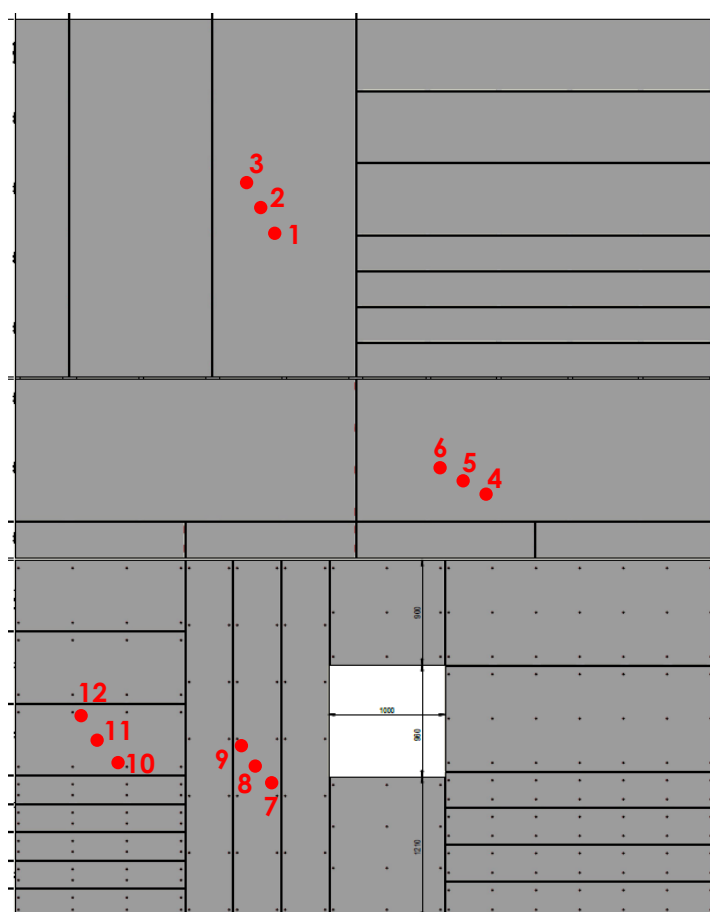
**Figure 3**

**Positions of Deflection Measurement Probes**

- Deflection probe position

Probe Group Identification	Calculation of deflection
Group A comprised of probes 1, 2 & 3	= Probe 2 – ((Probe 1 + Probe 3)/2)
Group B comprised of probes 4, 5 & 6	= Probe 5 – ((Probe 4 + Probe 6)/2)
Group C comprised of probes 7, 8 & 9	= Probe 8 – ((Probe 7 + Probe 9)/2)
Group D comprised of probes 10, 11 & 12	= Probe 11 – ((Probe 10 + Probe 12)/2)

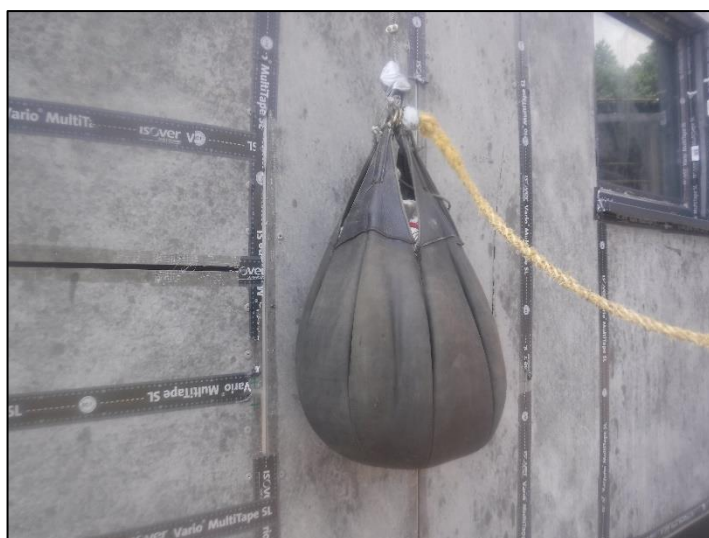
Photograph No. 3

Showing Soft Body (S1) impact of 120Nm.

During the above test, no damage was observed.

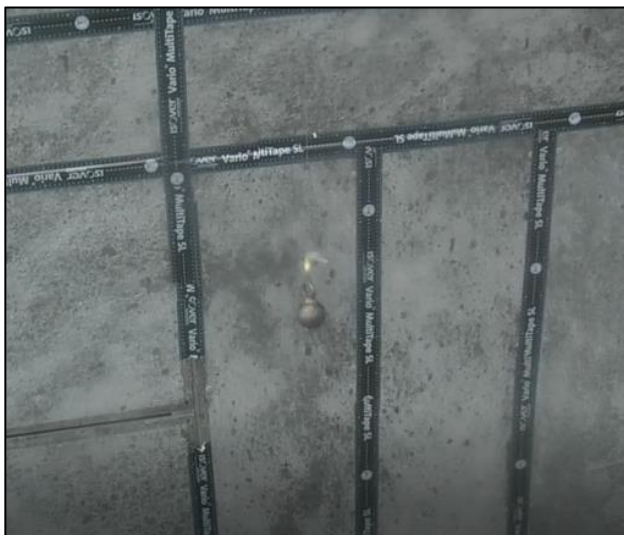
Photograph No. 4

Showing Hard Body (H2) impact of 10 Nm.

During the above test, no damage was observed.

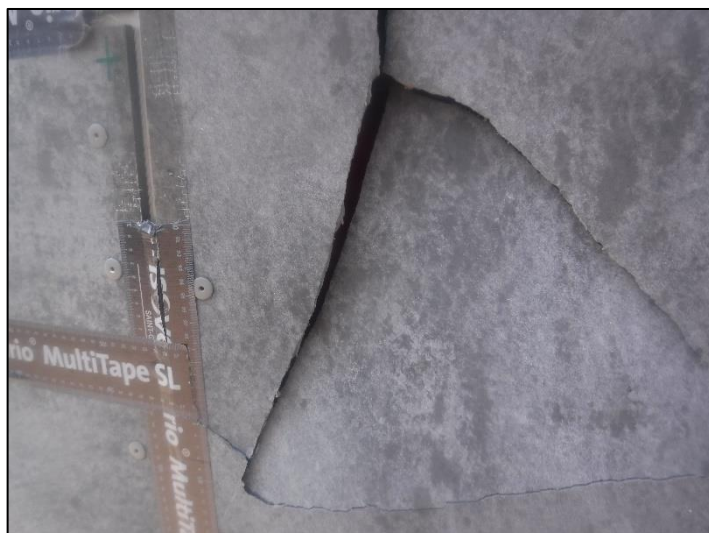
Photograph No. 5

Showing damage caused following Soft Body (S1) impact of 500 Nm.

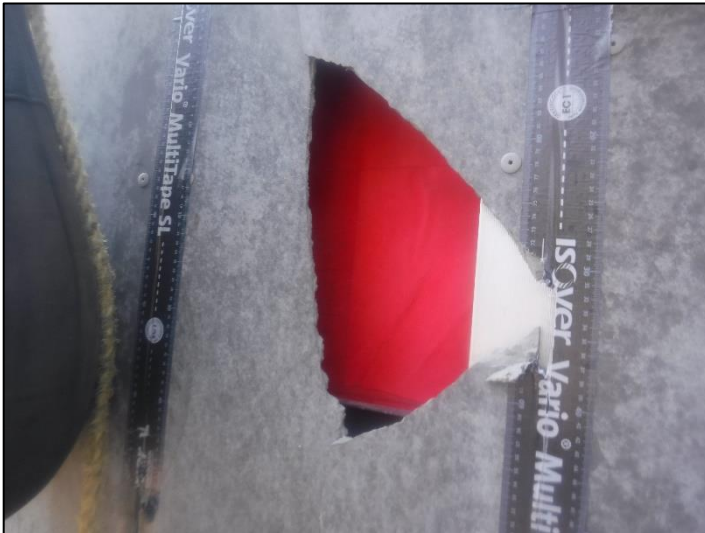
Photograph No. 6

Showing damage caused following Soft Body (S1) impact of 500 Nm.

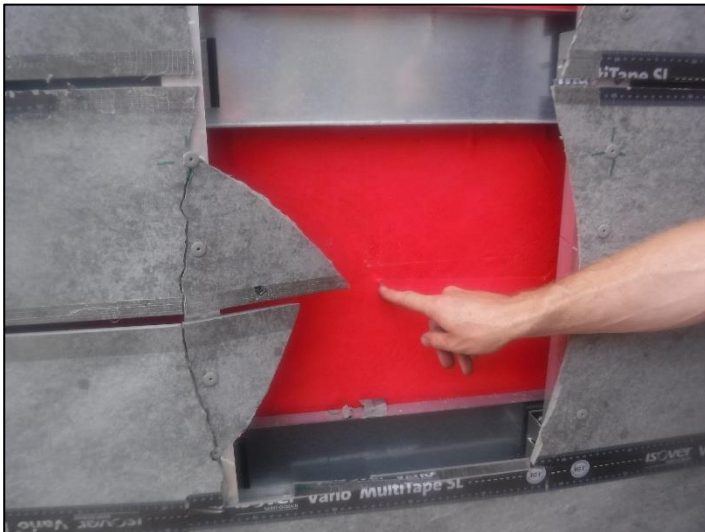
Photograph No. 7

Showing damage caused to backing wall following Soft Body (S1) impact of 500 Nm.

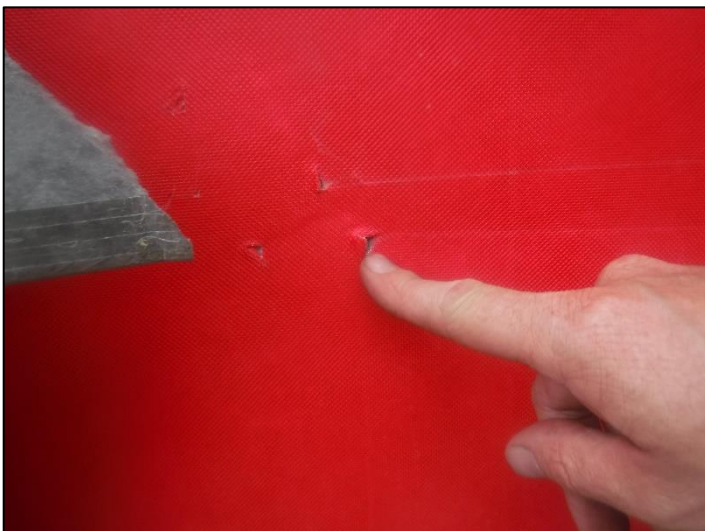
Photograph No.8

Showing damage caused to backing wall following Soft Body (S1) impact of 500 Nm.

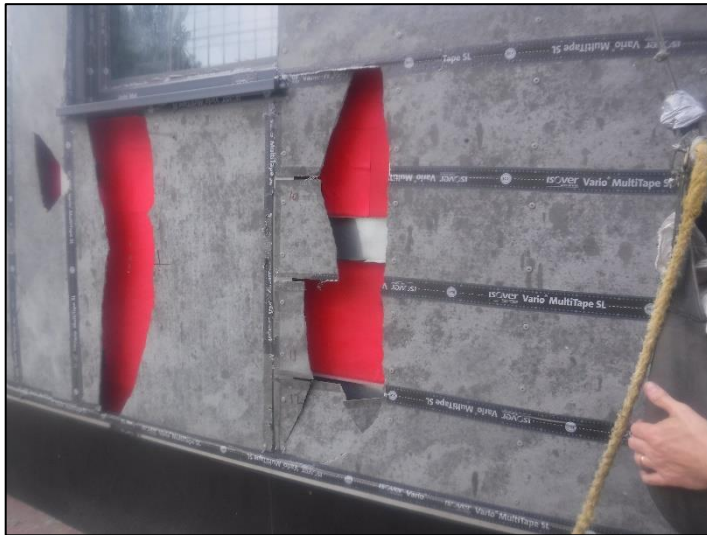
Photograph No. 9

Showing damage caused following  
Soft Body (S1) impact of 500 Nm.

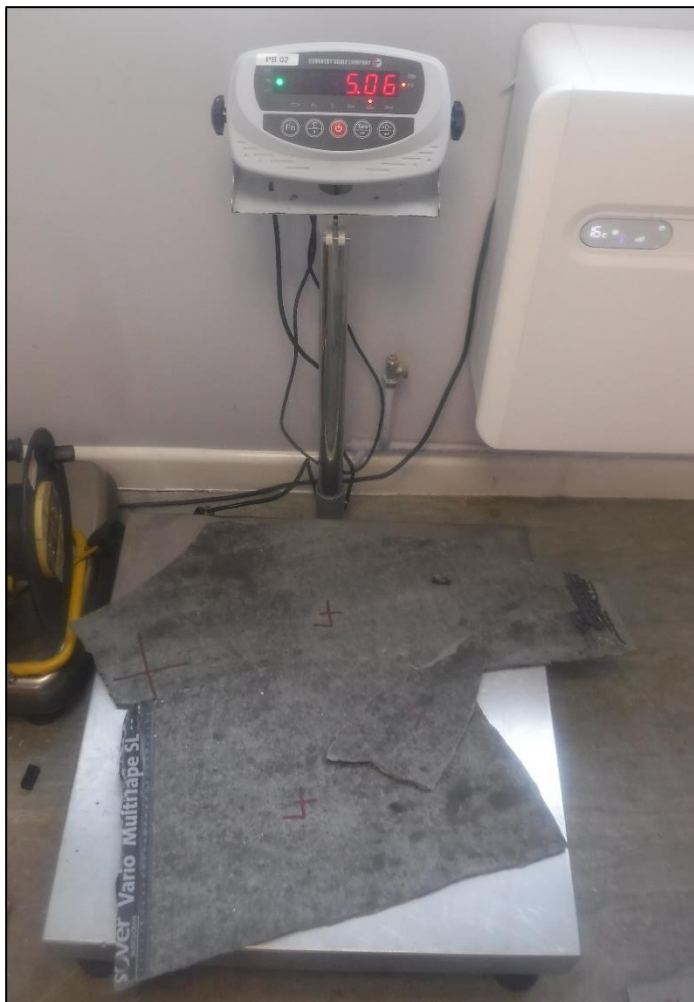
Photograph No. 10

Showing weight of pieces that fell off  
following Soft Body (S1) impact of  
500 Nm.

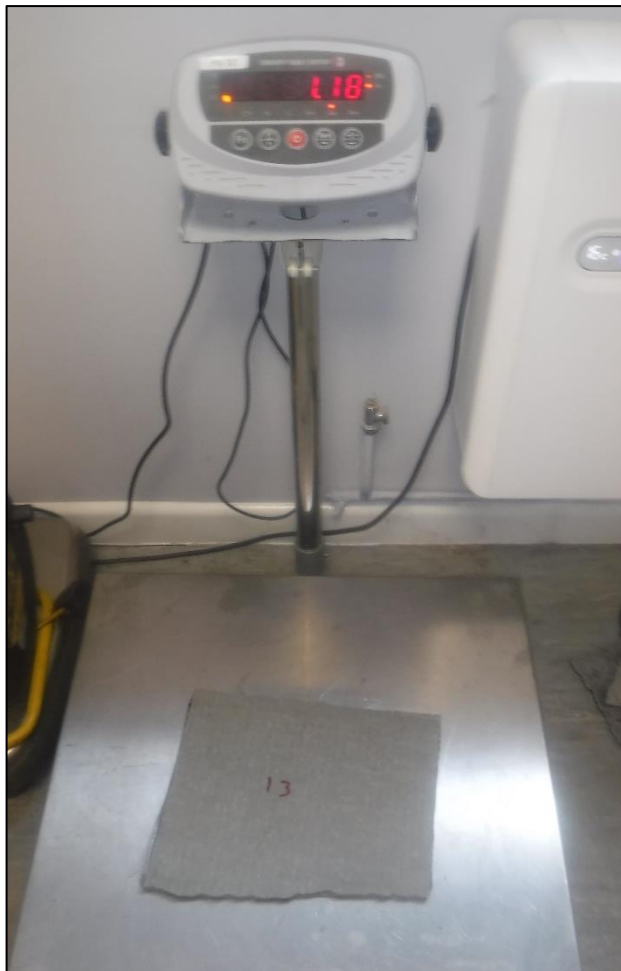
Photograph No. 11

Showing weight of pieces that fell off following Soft Body (S1) impact of 500 Nm.

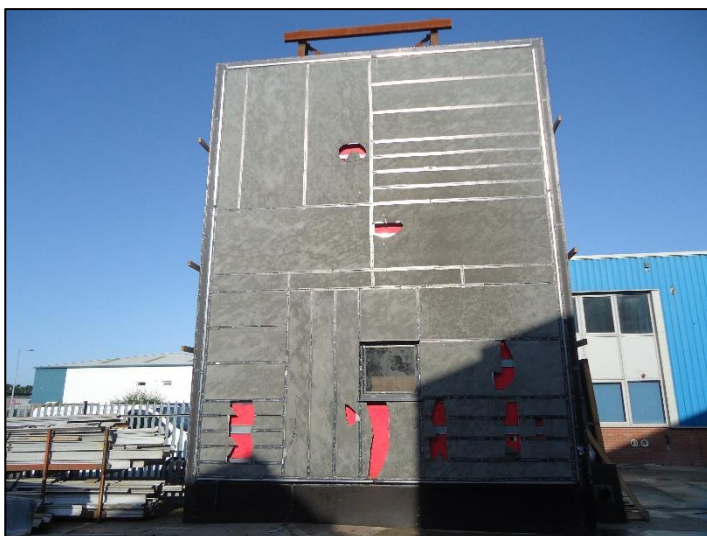
Photograph No. 12

Showing extent of damage caused following Soft Body (S1) impact of 500 Nm.

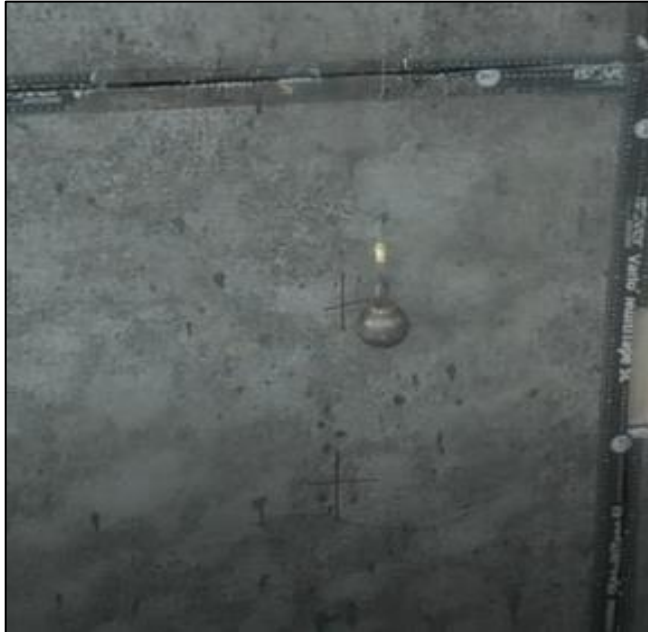
Photograph No. 13

Showing Hard Body (H2) impact of 10 Nm.

During the above test, no damage was observed.

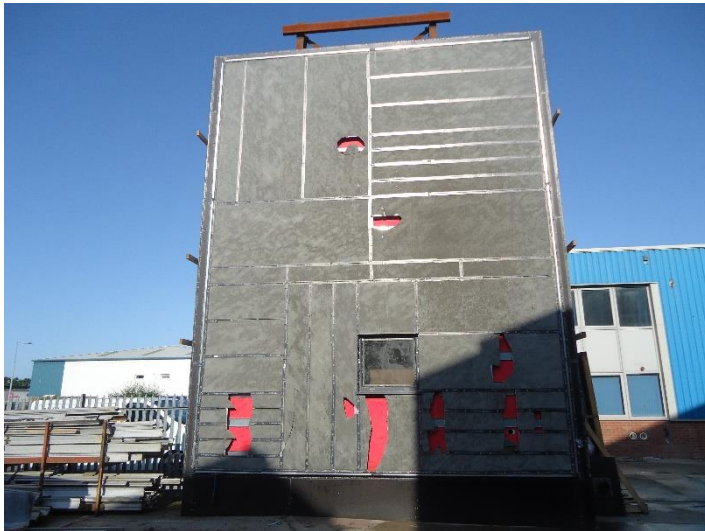
Photograph No. 14

Sample prior to dismantle

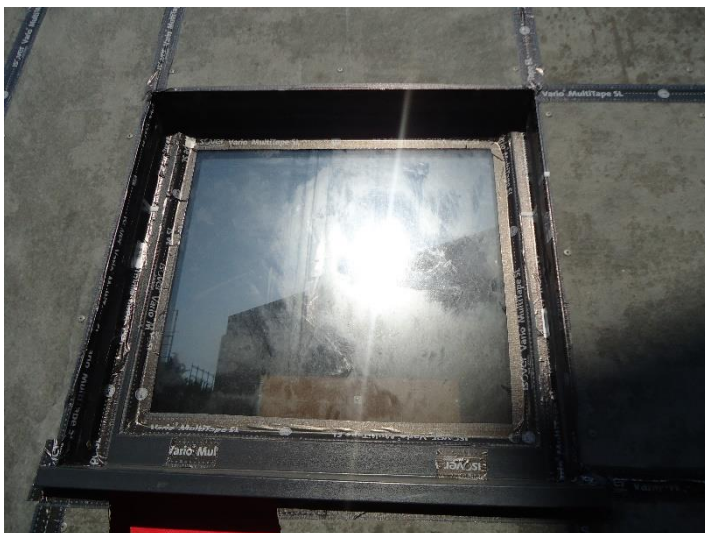
Photograph No. 15

Window pod detail

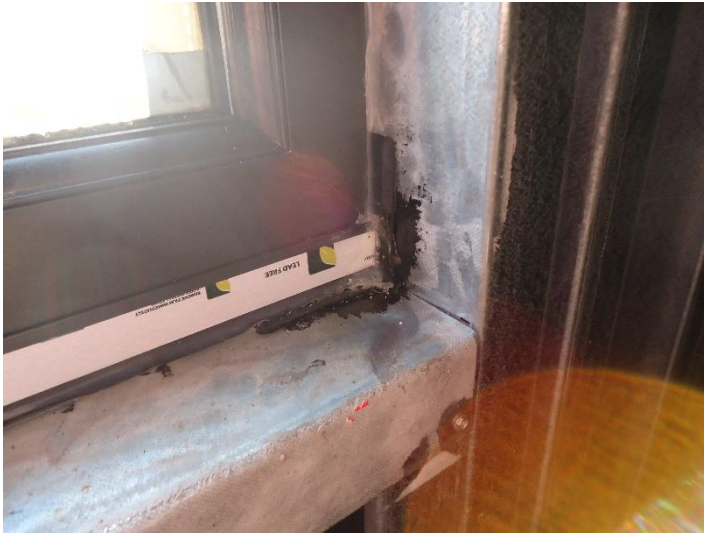
Photograph No. 16

Internal window pod  
interface detail

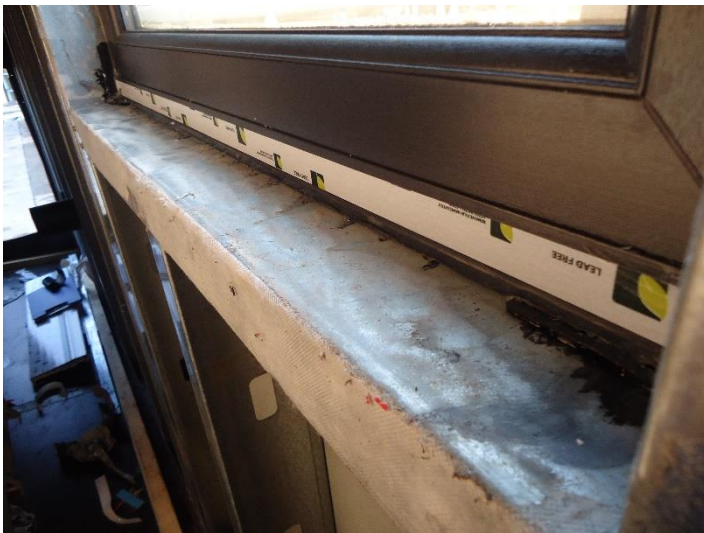
Photograph No. 17

Internal window pod  
interface detail

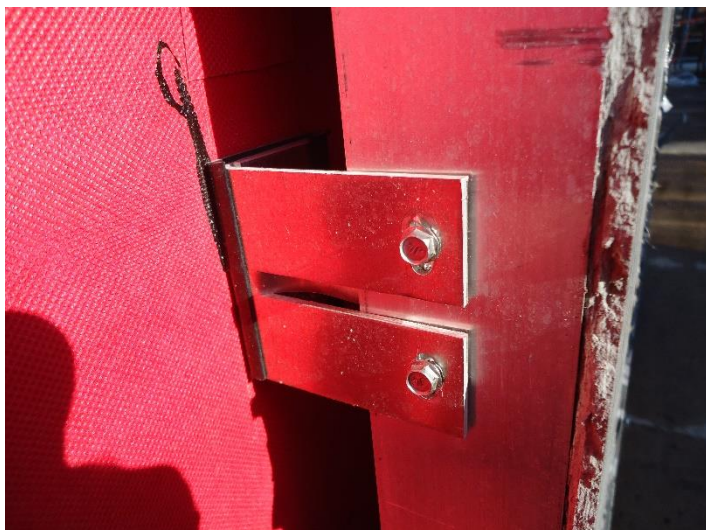
Photograph No. 18

Helping hand bracket and L-rail

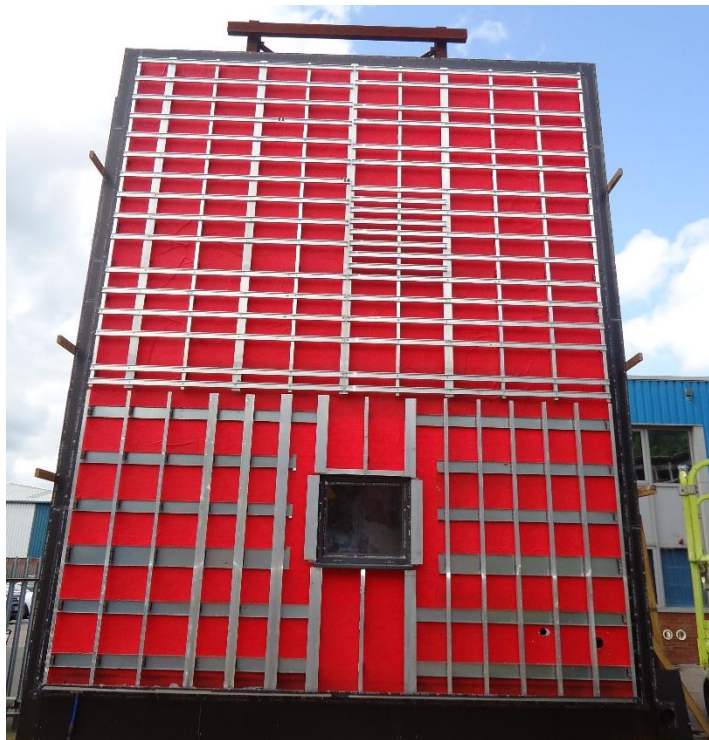
Photograph No. 19

Backing support rail layout

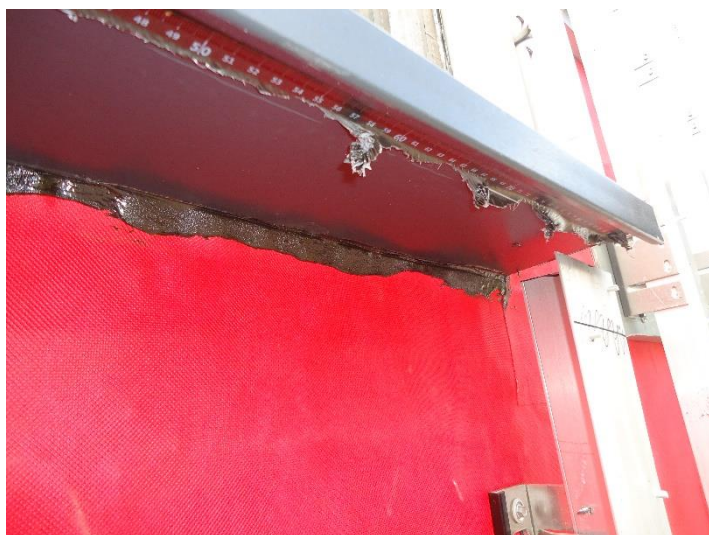
Photograph No. 20

Sealant on underside of  
window cill

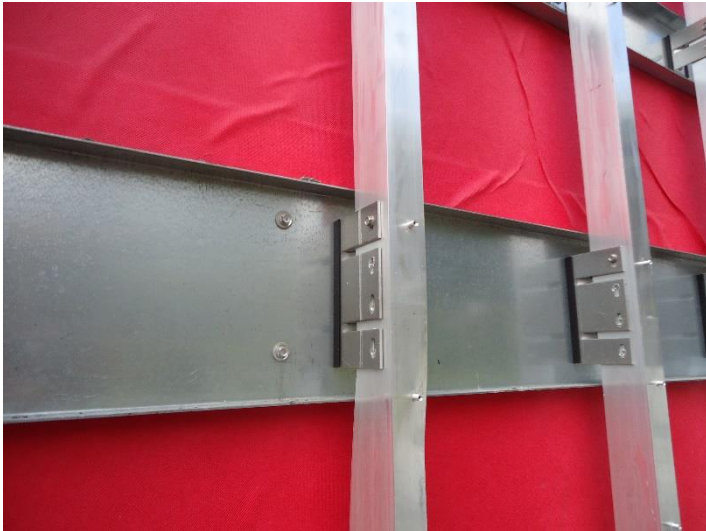
Photograph No. 21

Large helping hand bracket  
and L-rail

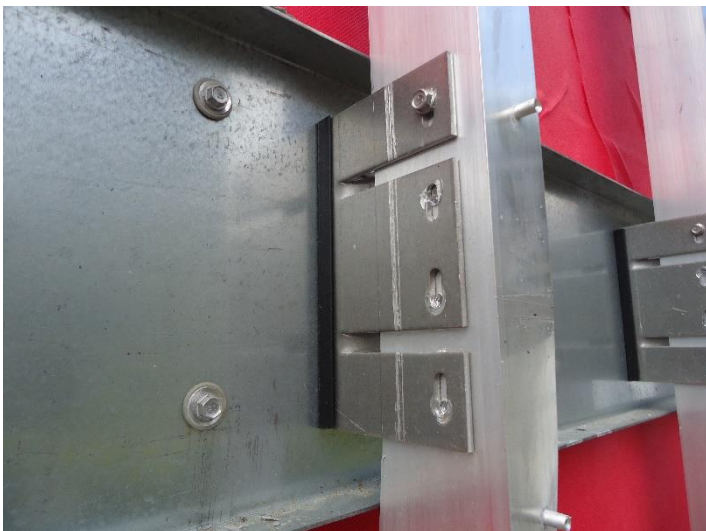
Photograph No. 22

Large helping hand bracket  
and L-rail

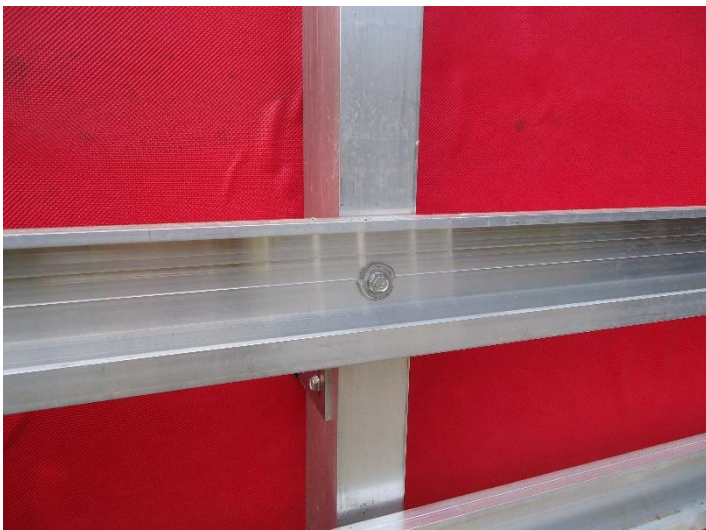
Photograph No. 23

Top secret fix rail

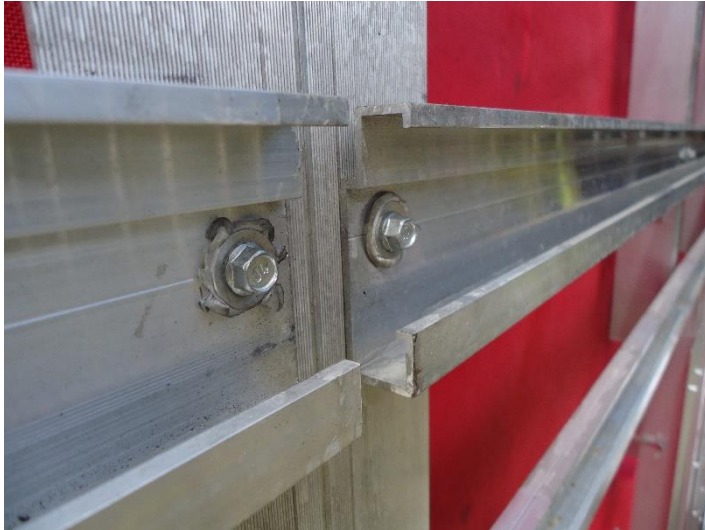
Photograph No. 24

Expansion joint on secret  
fixing rail on T-rail

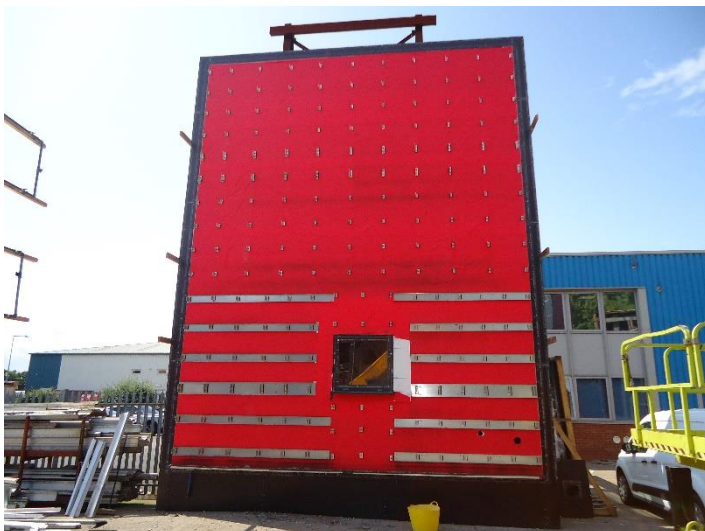
Photograph No. 25

Helping hand full layout

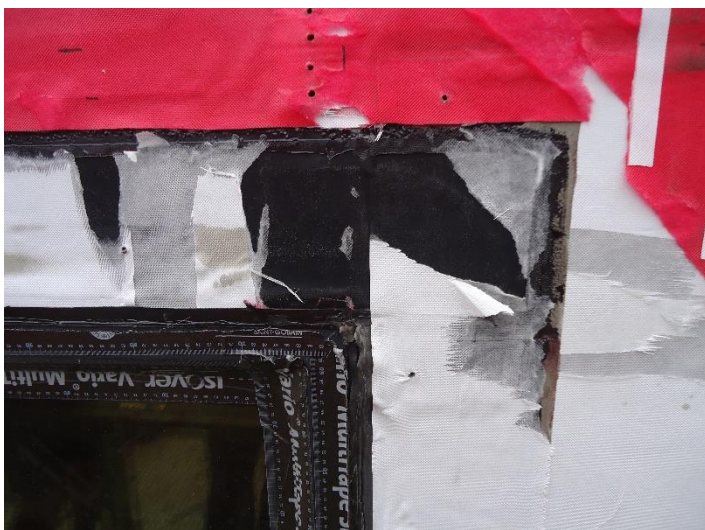
Photograph No. 26

EPDM around window pod  
detail
